Table of Contents

General Information

Others Present Vacant
 Estimated Age Entrance Faces
 Inspection Date
 Start Time 9:00am End Time 1:00pm
 Electric On Yes No Not Applicable
 Gas/Oil On Yes No Not Applicable
 Water On Yes No Not Applicable
 Temperature 73 degrees
 Weather Partly cloudy Soil Conditions Dry- No precipitation for past 2 weeks
 Space Below Grade Basement
 Building Type Single family Garage Detached
 Sewage Disposal City How Verified Visual Inspection

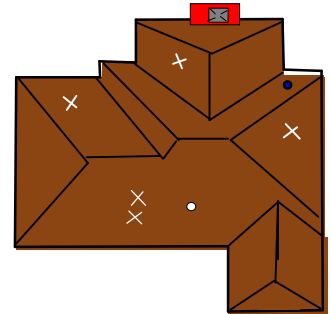
2. Roof Diagram

Material: Fiberglass shingle

Nail popping through shingle surface in various locations causing potential water intrusion (see diagram above marked "x")

- 4. Main Roof Surface Material: Fiberglass shingle Nail popping through shingle surface in various locations causing potential water intrusion (see diagram above marked "x")
